PITTSBURGH BRIDGE COLLAPSE

5/9/2023

In January 2022, a bridge collapsed in Pittsburgh. This commentary discusses two aspects of the incident to help mitigate risks of recurrence.

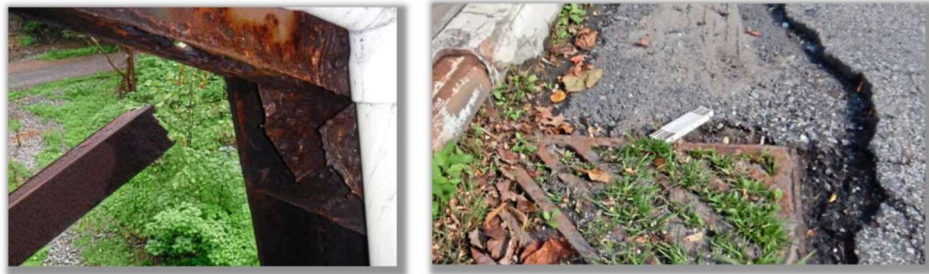
The investigation found a history of degradation and recommended repairs to correct some root causes. Those causes included “crumbling concrete” and deterioration of “overlapping joint areas” driven by insufficient corrosion protection¹. Inspectors said two of the “lower bracing members are completely severed” in a 2018 message. Note that the identified causes are consistent with my estimates. The critical joints shown below² (including base material, welding, and fasteners) were failing.

Figure 1. Detached structural joint. Degraded concrete and pavement. Blocked drainage.

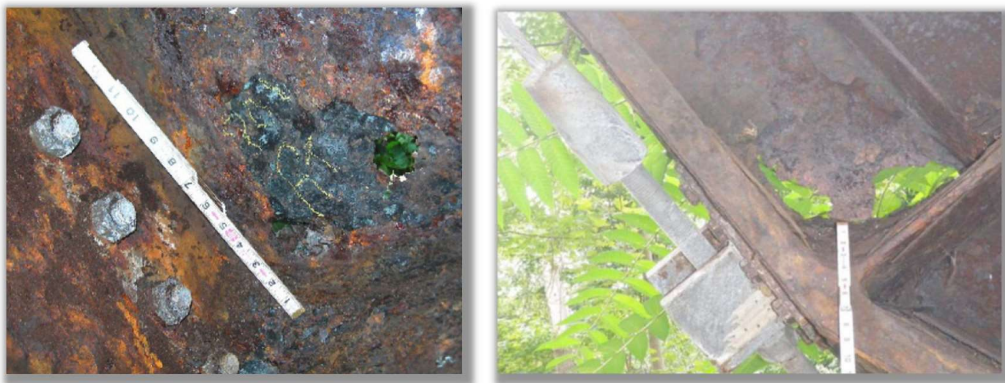
Figure 2. Corroded joint with bolts. Corroded joint with various fasteners.
